Locomotive Collision Test #2

Grade Crossing Collision of a Freight Locomotive with a Log Truck

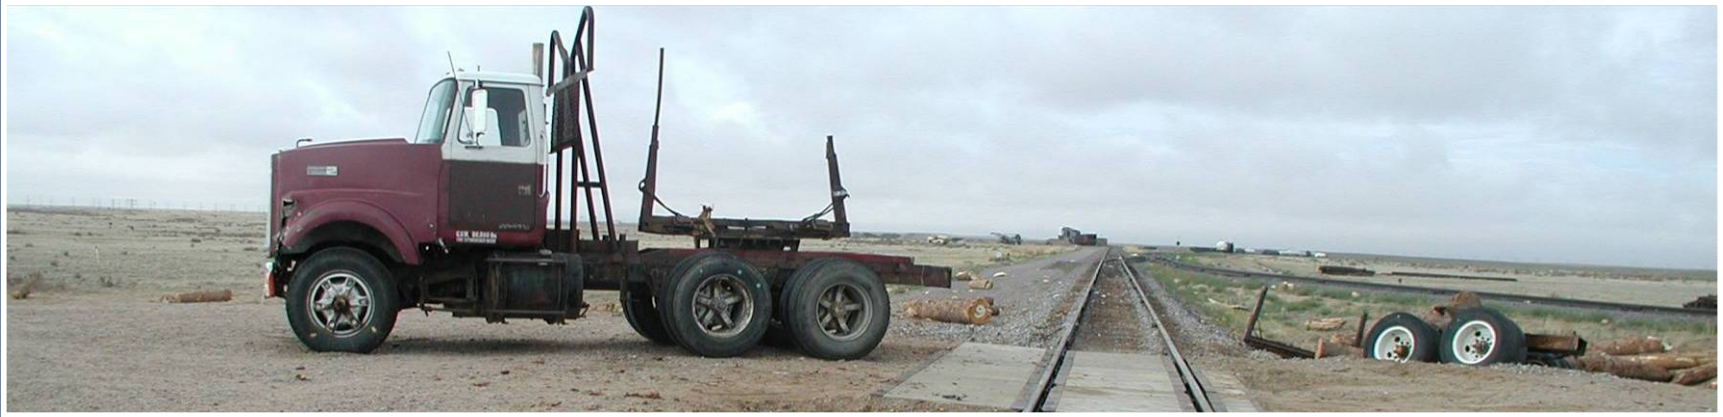
Position of log truck following collision test

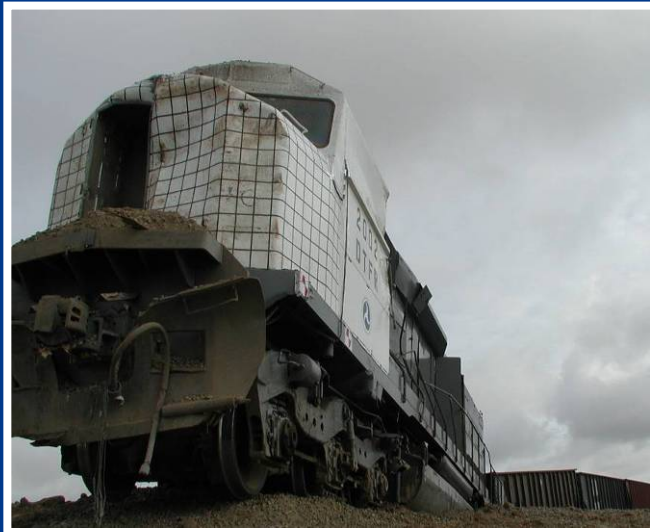
Position of locomotive following collision test

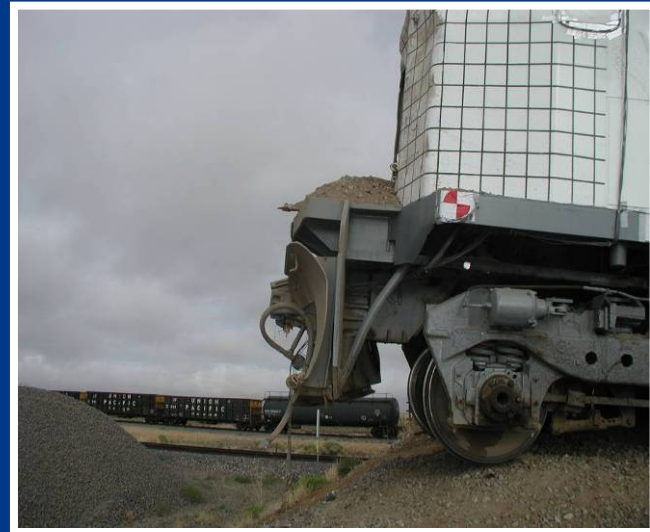
Minimum damage to locomotive end plate and anticlimber

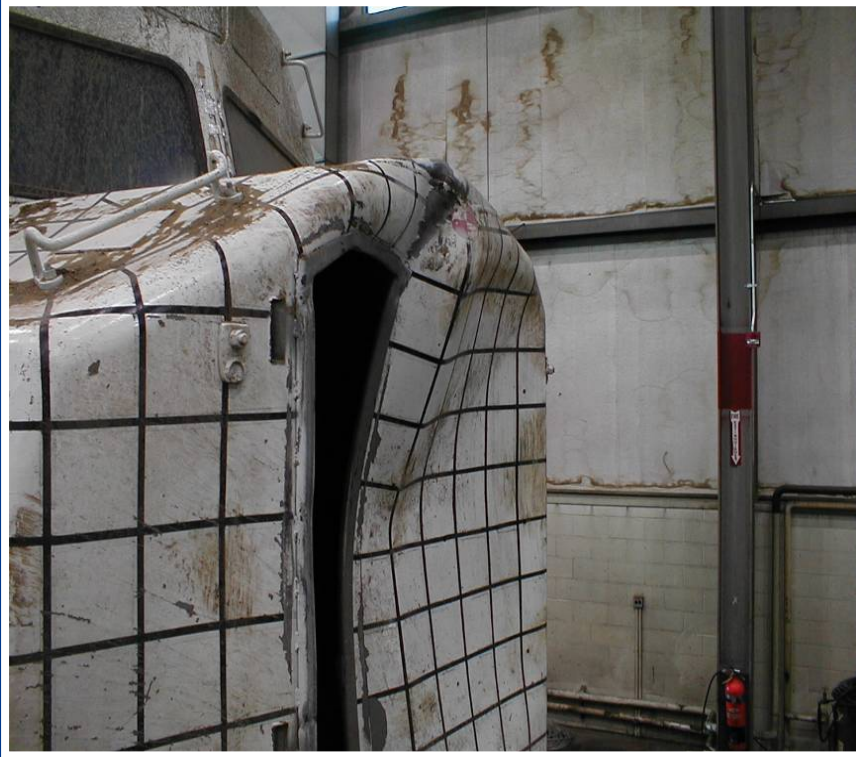
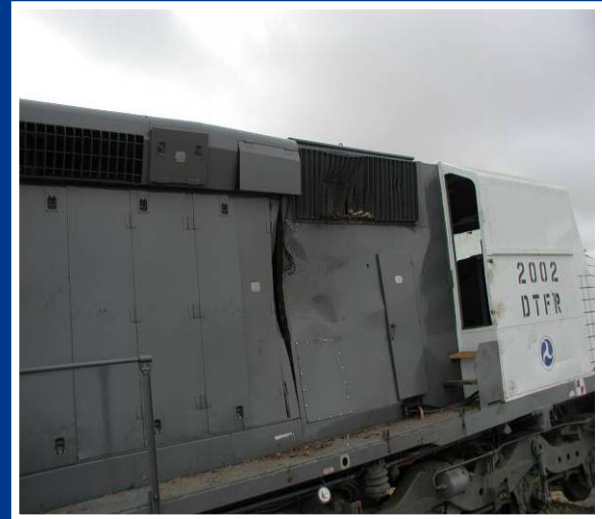
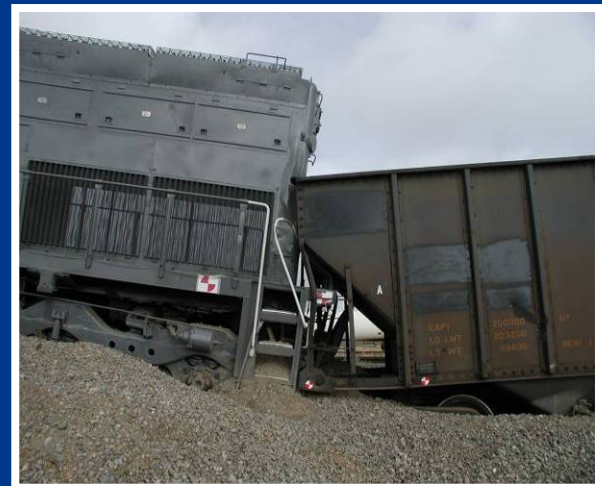
Hood and car body damage from logs
and subsequent hopper car impact

- What did we learn from this test?
 - Log truck impact did not significantly slow the locomotive
 - Collision posts not damaged, hood and sides of locomotive suffered some damage
 - Windshield posts are not significantly damaged, indicating that the crew safety would not be affected in this type of collision
 - Brake cylinder damaged by flailing log, caused loss of air pressure and brake power
